CASE STUDY

FRENCH BROAD RIVER

Riverbank Restoration - Del Rio, TN

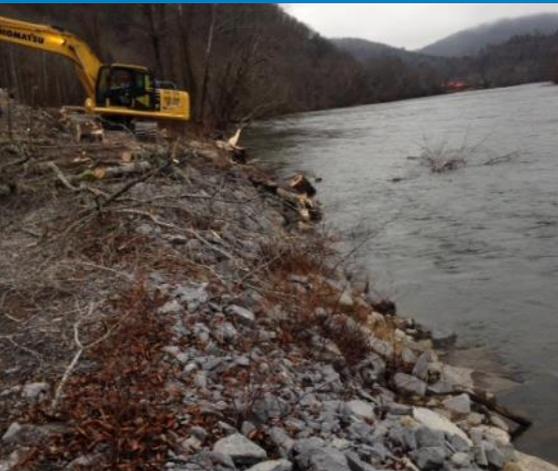
A section of bank had been severely damaged due to flooding conditions as construction of a new bridge over the river was in progress. The bank erosion threatened both the recently installed bridge infrastructure and a railroad line running parallel to the eroded bank slope. Under emergency conditions just after the flood, TDOT placed thousands of tons of Class II riprap on the slope for temporary stabilization. The emergency repair plan included the regulatory directive that an engineered, permanently vegetative stabilization method(s) must be submitted, approved, and implemented.

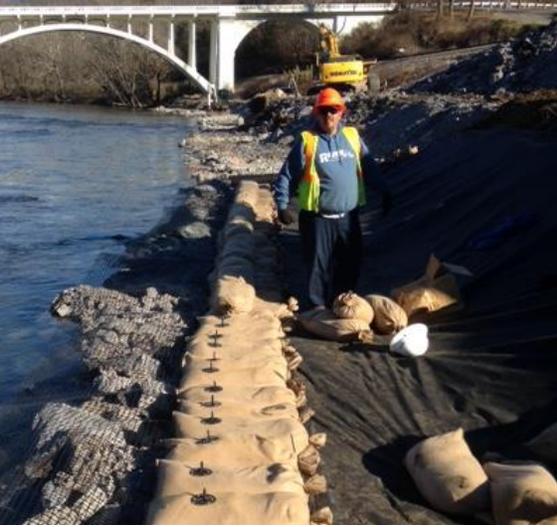
+French Broad River

RiverWorks was contracted to construct the approved repair plan. An existing temporary construction entrance from the previous emergency repair work was reworked to serve as site access for this project. The existing riprap on the slope was removed and stockpiled for reuse on the project. The 700 lf bank slope was regraded in preparation for the installation of 4,570 square feet of a vegetated MSE wall. A footing was excavated at the base of the slope and backfilled with the salvaged riprap.

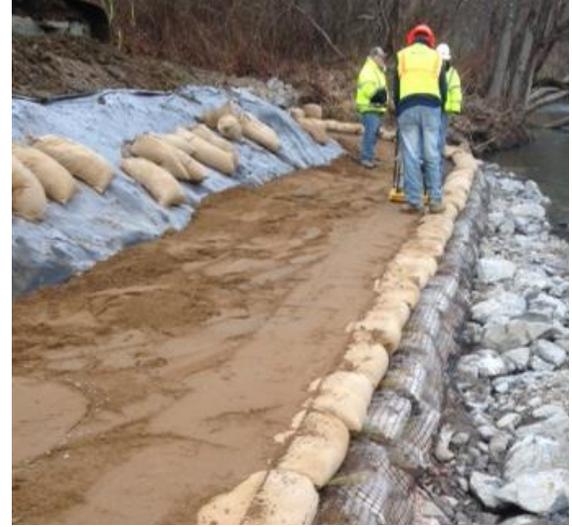
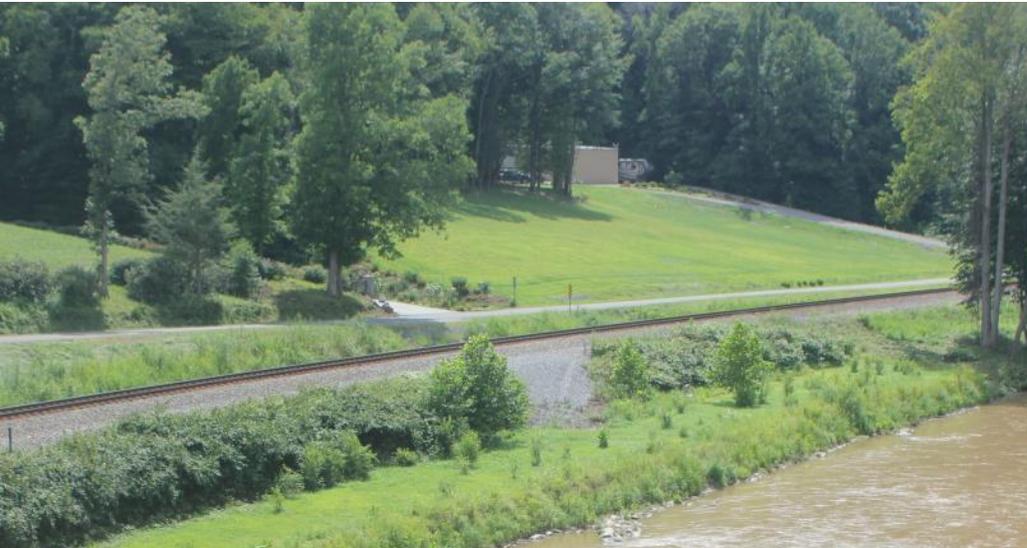
Along with the Envirolok system, geogrid was installed between the rows of bags on every third lift to provide stability into the existing slope. Duckbill anchors were utilized to further anchor the geogrid. The bag units were filled on-site with a sand/organic mix to provide an ideal growing medium. As rows of "Envirolok" were installed, proper backfill was installed and compacted with a plate compactor. Dormant brush material was placed between the bags on every third row for future deep rooted stabilization.

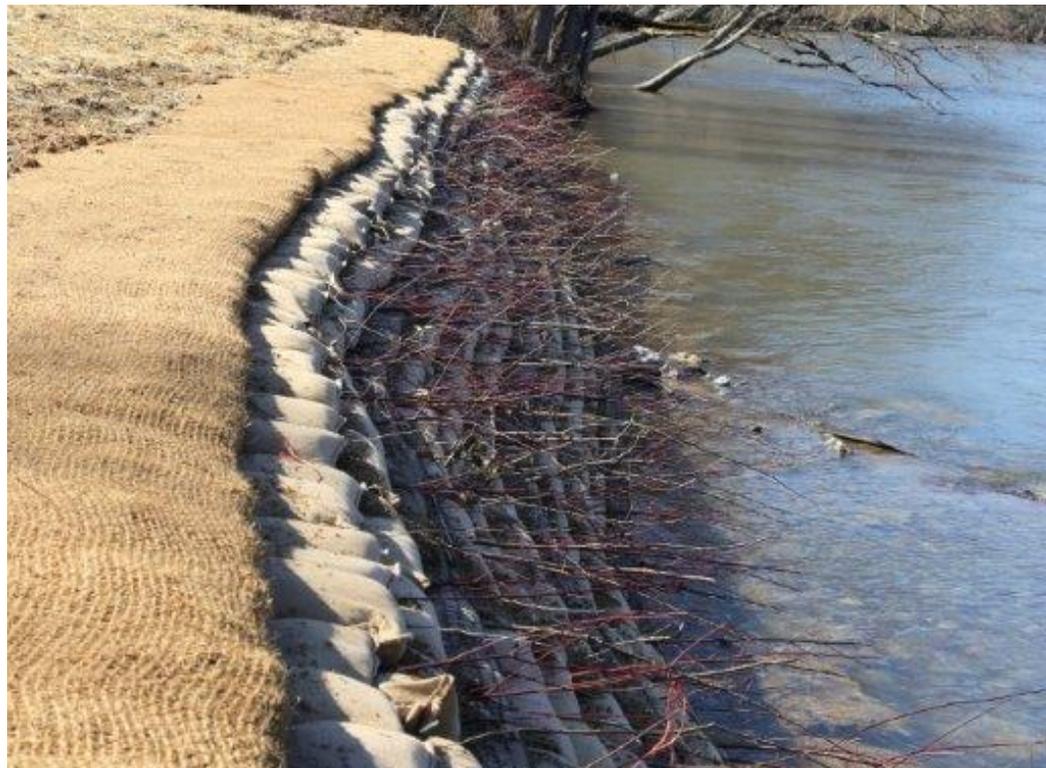
Boulders were imported and used to construct four boulder vanes into the river to direct normal stream flow away from the toe of the bank. After completion of the construction phase, the top of the slope and all other areas were seeded and mulched with a riparian seed mix with a temporary cover crop. During the dormant season native trees and shrubs were planted for long term stability. Continued monitoring of the site indicates that the slope vegetation and upland plantings have successfully stabilized the site.
