SLOPE STABILIZATION
CASE STUDIES

+ENGINEERED SLOPE STABILIZATION

GLENORCHY TRAIL - Slope Stabilization

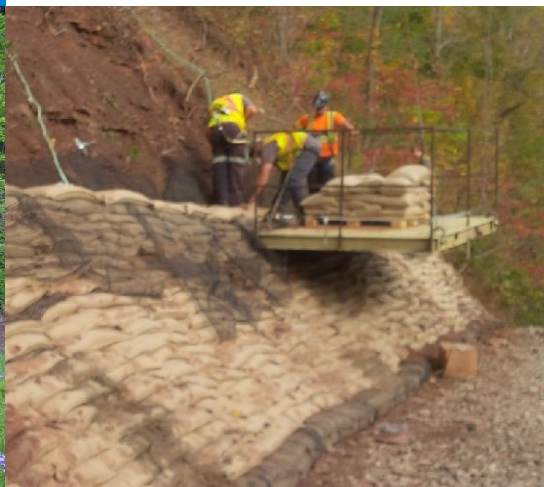
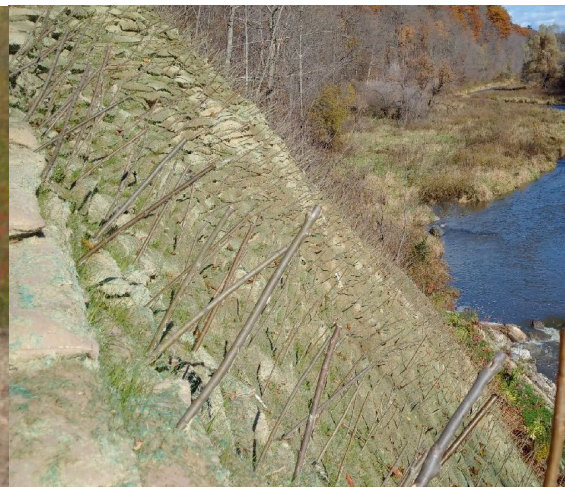
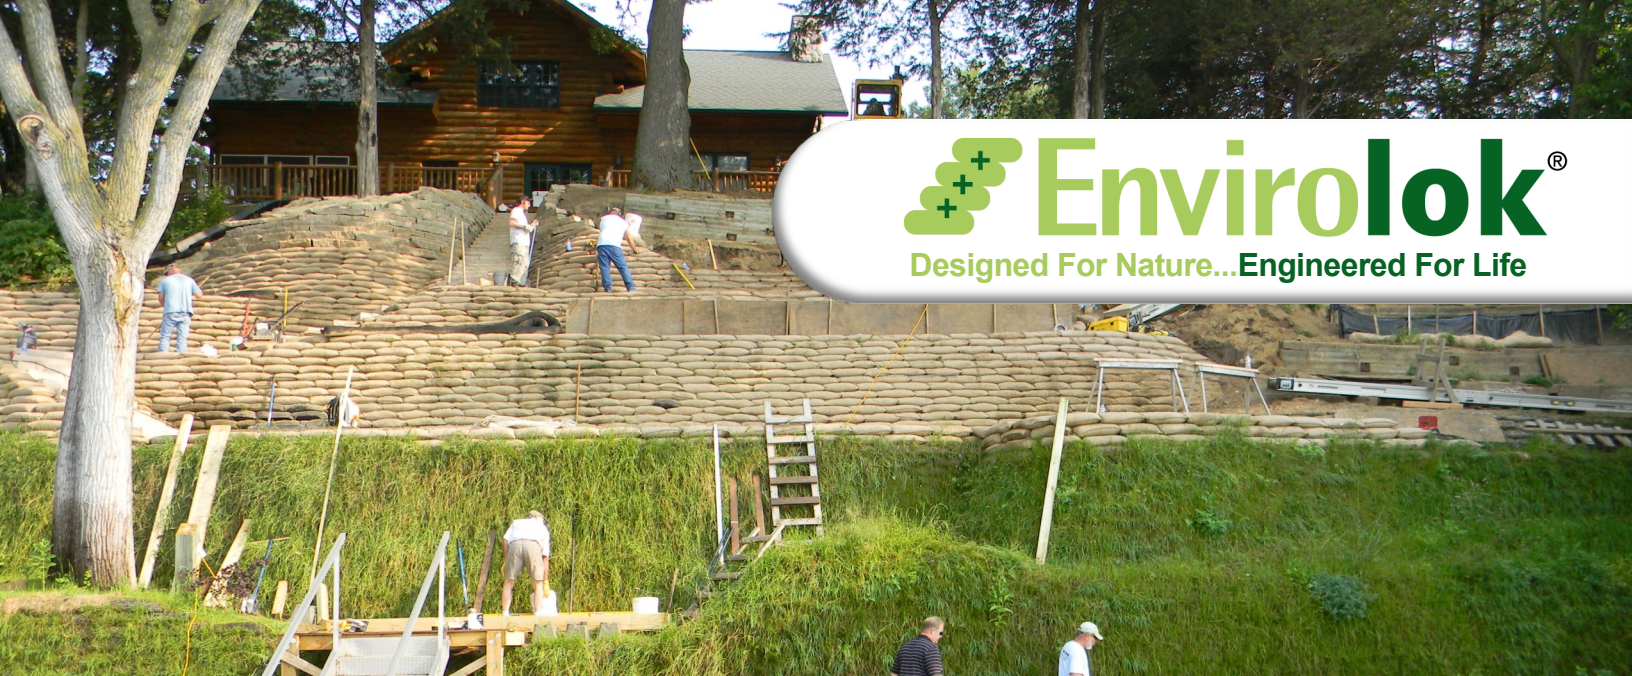
Due to Sixteen Mile Creek's scouring action, the subsurface clay shale of this steep slope was quickly eroding and no longer stable, preventing the slope from reaching a stable inclination. Town officials were concerned about this section of their well-used trail system failing. Envirolok was able to conform to the slope's natural contours easily, and due to limited accessibility, a crane was utilized to access the slope from across the creek. A mixture of geogrid and earth anchors was used to increase stability and shear strength along such a steep slope. A mix of native grasses and wildflowers was hydroseeded onto the slope, and then nearly 2000 live stakes of dogwood and willow were added along the slope face. The slope was fully vegetated within three months of construction, and the root systems added further strength and support. The Envirolok system successfully stabilized the slope and established a habitat along a sensitive area for the Glenorchy Conservation Area.

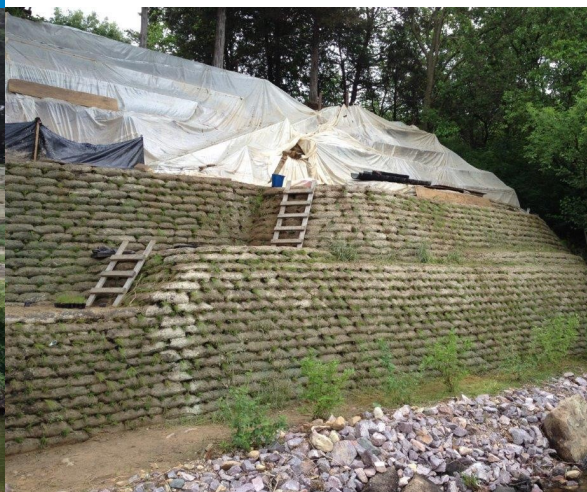
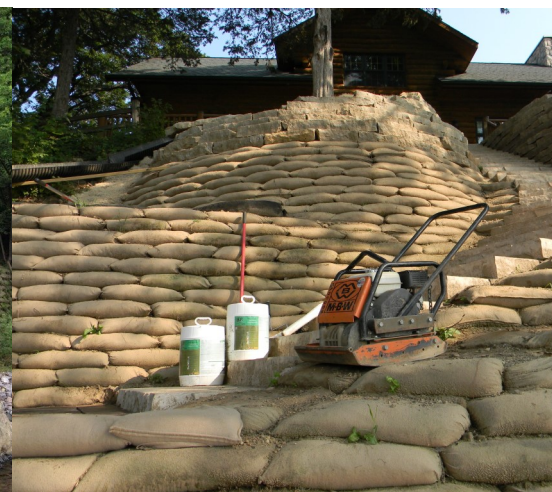
LAKE WISCONSIN - Slope Stabilization

A homeowner on Lake Wisconsin had a failing timber retaining wall that needed to be replaced. Upon reviewing the project and coordinating with regulatory agencies, options were limited. Replacing the current wood timbers with concrete was not allowed. Envirolok was chosen to stabilize this slope as it meets the required needs of the regulatory agencies. During construction, the timber retaining walls were removed in sections and replaced with the Envirolok Unit. Due to the steepness of the slope, geogrid and earth anchors were used to strengthen and stabilize the slope. Due to the large scale of this project, it was completed over multiple years in various stages. Native plant plugs and hydroseeding were used to vegetate the walls. The Envirolok system met all the requirements for this project and exceeded expectations. Due to the flexibility and easy installation, this large-scale project with multiple terraces and steep slopes will be stabilized for many years to come.
