# LAKE MENDOTA - Slope Stabilization

## + Project Snapshot

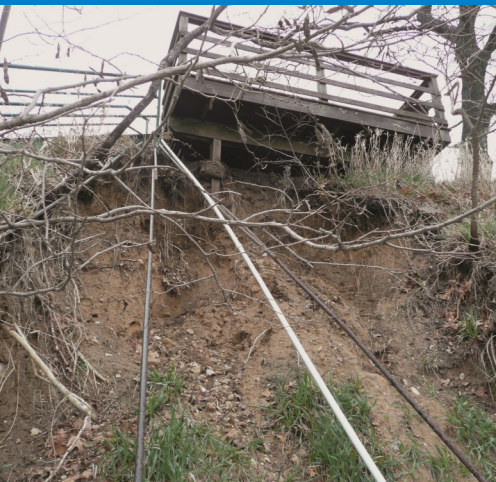
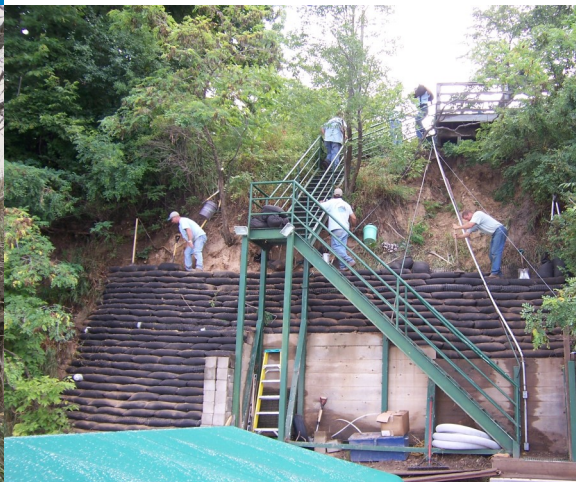
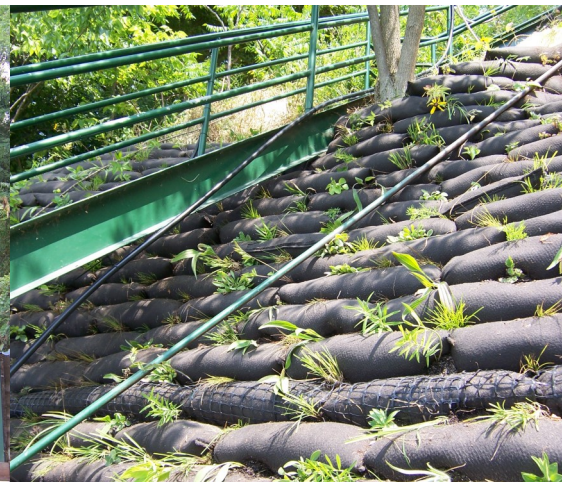
This lakefront resident had a steep un-vegetated slope that was eroding into the lake with every rain event. Record high lake levels combined with wave action eroded the base of the hillside causing severe hillside instability. During excessive rains, the hillside slipped down the slope, hitting the steel guard railing and bending the structure. The hillside slip exposed the outlook platform's supporting post and its concrete footing, making the outlook platform very unstable. There is an ancient Eagle Indian Effigy Mound at the top of the slope that was being threatened by this erosion. The residence owner was concerned with preserving the slope, the overlook platform, stairway, and the Indian Effigy Mound. Envirolok created the opportunity to stabilize the slope, promote vegetation, and protect the existing structures from further damage. Due to the steepness of the slope, a combination of geogrid and earth anchors was used to create maximum stability and support. After construction, the retaining wall was vegetated with native species via plant plugs and hydroseeding.
